Evaluation and Recommendations for High Crash Locations in Kennebec County

Prepared by Kennebec Valley Council of Governments
Draft, December, 2016; Revised, with DOT Action Plan added, June, 2017

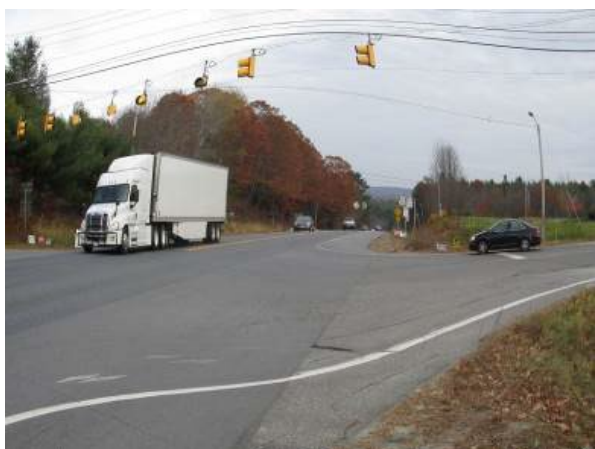
The hazards at this intersection clearly involve vehicles turning while other vehicles are travelling at highway speeds. Although well-signaled, the intersection is at the top of a grade, where westbound left-turning vehicles often stand while waiting for oncoming traffic to clear. This includes tractor-trailers turning on to Main Street bound for the Sabattus interchange, which must also negotiate a wide turn if vehicles are standing at the stop line on Main Street. Following

traffic often passes in the breakdown lane. It was noted during the site visit that one of the flashing beacon lights was inoperative.

Monmouth: Looking east on Route 202 towards Main Street intersection on right

- Repair inoperative flashing beacon light.
- Clear right-of-way vegetation in distance from southwest corner.
- Evaluate need for left-turn pocket westbound on Route 202.
- Widen throat at Main Street leg to accommodate the swing of large trucks.

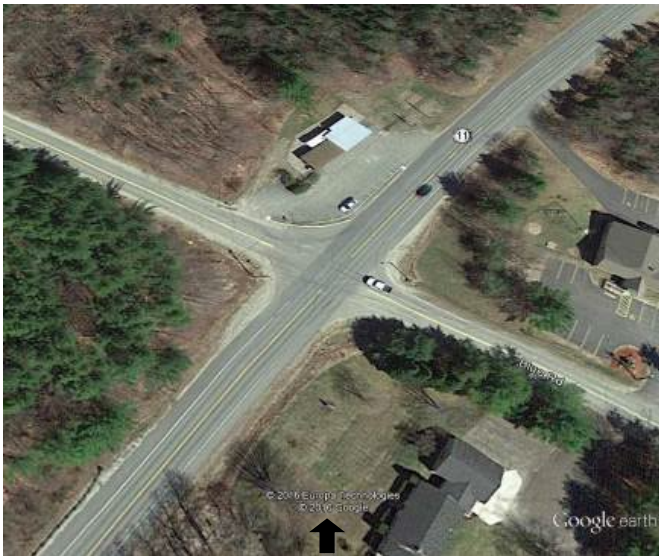
The hazards at this intersection are typical of a high speed, low-volume rural crossing. There is a slight reduction of sight distance on Route 202 heading east into the intersection due to a gradual curve and vegetation on the northwest corner. Additional evergreen vegetation south of 202 and along Blue Road may contribute to icy conditions, but may be located on private property. The business on the northeast corner is a fireworks store, seasonally busy, and the tier of parking along the curb when occupied interferes with sight distance.

Monmouth: Intersection of Route 202/Blue Road (to southeast)/Bog Road (to northwest). Note fireworks store on north corner and tall vegetation close to road (Image: Google Earth)

- Relocate the STOP Bar closer to the Rte. 202 shoulder line and relocate the STOP signs to increase their visibility.
- Consider adding oversized STOP signs on Bog Road to improve visibility.
- Negotiate removal or relocation of parking tier with business owner on northeast corner (may be in state r/w).

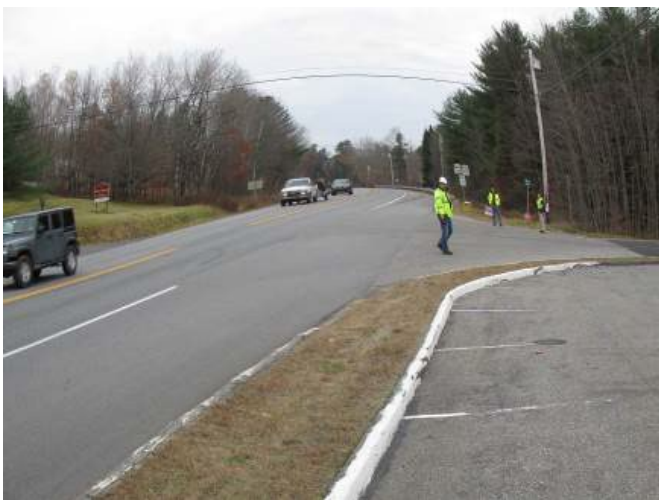
Looking southwest on Route 202 towards Bog Road on right from fireworks parking lot.

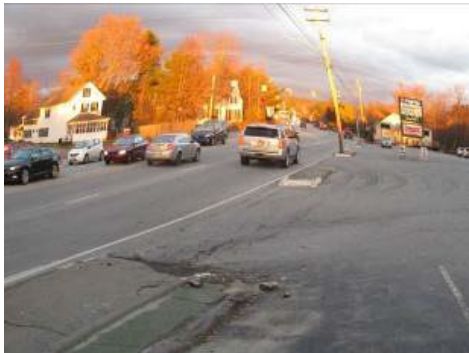
Section 3115993 adjoins a busy intersection that is not an HCL, but within the section, there have been eight crashes in the three-year period. Of the eight crashes, seven of them appear to be associated with turning movements into or out of the convenience store/Dunkin Donuts. Six are attributed to “failure to yield.” All occurred during daylight hours.

Manchester, Route 202 looking east through curb cuts at Mulligans/Dunkin Donuts

- Coordinate traffic signals between Granite Hill Road and Route 17 to permit larger gaps in traffic. Note that the municipality has collected \$10,000 in impact fees for this purpose.
- Grind out old striping and repaint center-road striping.
- Evaluate left turn pocket for westbound turn into Granite Hill Road and eastbound center lane to see if transition can move further westward.

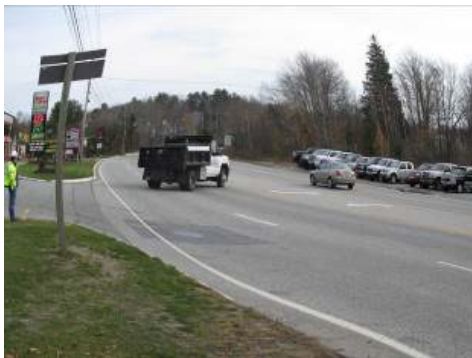
Section 3108742 experienced 13 crashes during the three-year period, four of which resulted in injury. All but one of the 13 appear to be associated with turning movements into or out of the J & S Oil service station. All of those are attributed to “failure to yield.” Three vehicles were attempting to enter the development from eastbound Route 202; of the nine exiting, five were attempting to turn left to eastbound, one was turning right but into the left-hand lane, and three were unclear from the crash diagram. There did not seem to be a discernable pattern in time of day or year.

Manchester, Route 202 looking east at J & S Oil western curb cut

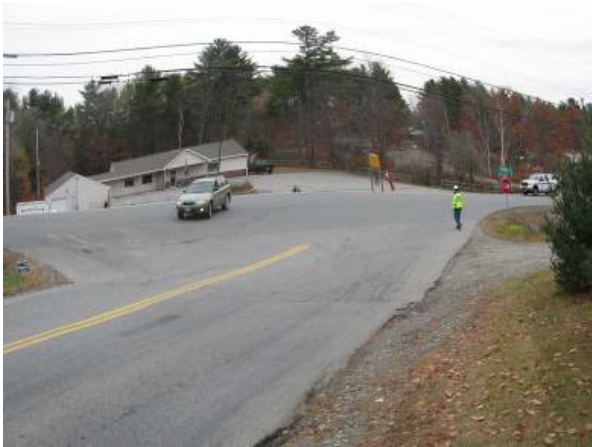
The Summerhaven leg of the intersection is fairly wide. Summerhaven Road approaches the intersection over a slight hill and at a fairly pronounced downward grade. This could definitely contribute to loss of control on wet or snowy roads if vehicles came over the hill without slowing. A STOP AHEAD sign on Summerhaven Road is located about 550 feet from the intersection. The hill to the north on Route 27 contributes to a lack of sight distance. This could cause uncertainty on the part of drivers entering from Summerhaven Road.

On Summerhaven Road, approach to intersection with Route 27

- Place a second, oversized STOP sign on the left side of the Sumerhaven Road to aid visibility, and increase the size of the right-hand sign, moving it closer to the edge of the road and STOP bar.
- Extend the double yellow line on Summerhaven Road so that it approaches the Route 27 edge-of-travelled-way, and add a stop bar.

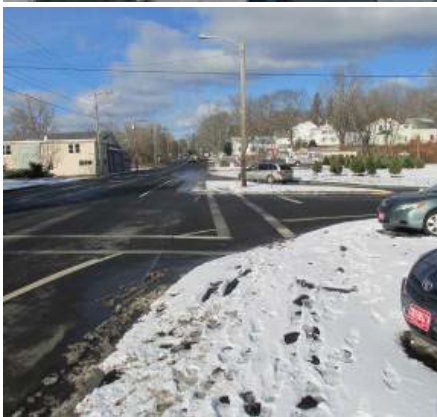
The intersection is constrained by tight circumstances. The right-of-way does not extend beyond the edge of the sidewalk on the east side. The auto repair shop on the southeast corner is wedged in and cars are parked immediately adjacent to the shoulder line, obstructing sight distance.

Randolph: On Water Street looking north towards Windsor Street intersection. Note cars parked close to corner.

- The island separating the intersection from the slip lane can be extended closer to the shoulder line with STOP and YIELD lines coming out correspondingly, allowing drivers from Windsor Street to venture further past the sight obstruction. The anticipated expense of doing so would likely make this a capital project.
- The light pole located within the traffic island should be moved to the west side of Water Street.
- Mitigation for the new development should focus on redesign of the slip lane with a longer merge onto Water Street.
- The business on the southeast corner should prohibit parking up against the right-of-way.

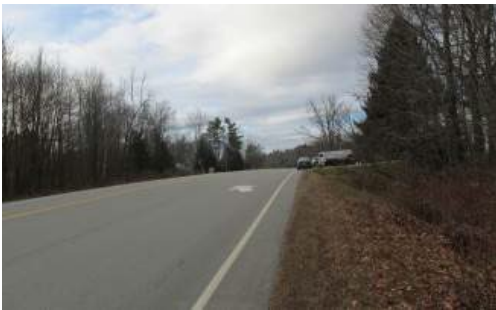
Although this segment is showing up as the HCL, clearly the hazardous portion of this roadway is the intersection at the southwestern end. It is one of the two intersections in Maine with two separate fatal crashes. Part of the cause is the lack of sight distance for entering traffic at the crest of the hill, part is the two lanes of westbound traffic to cross, and part is the speeds along the roadway. The climbing lane is too short to accomplish much and vehicles are speeding up to finish a pass and merge; entering vehicles must gauge closing speeds with less-than-ideal sight distance.

Vassalboro: North Belfast Ave. westbound top end of climbing lane approaching Stone Road intersection.

- Eliminate the climbing lane, which is too short to fulfill its function, and consider restriping the roadway to allow for the addition of left turn lanes within the existing travel way footprint.

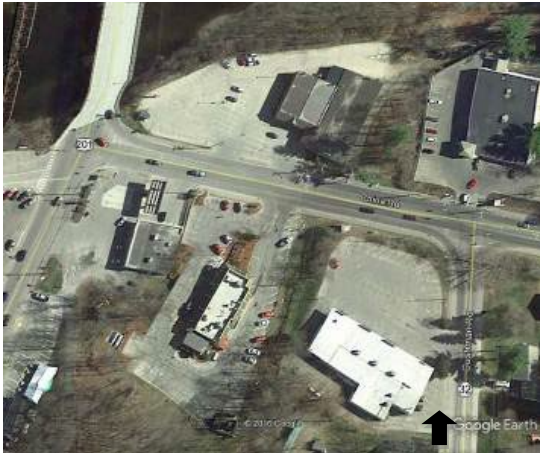
China Road (Route 137) from Bay Street (left) to Cushman Road. Midblock crosswalk striping is not visible (paint worn). (Image: Google Earth)

- Install a RRFB at the crosswalk.
- Install lane-keeping striping for the left turn from Bay Street onto China Road.
- Consider permitting a left turn option from the right-hand Bay Street lane in conjunction with lane-keeping striping.

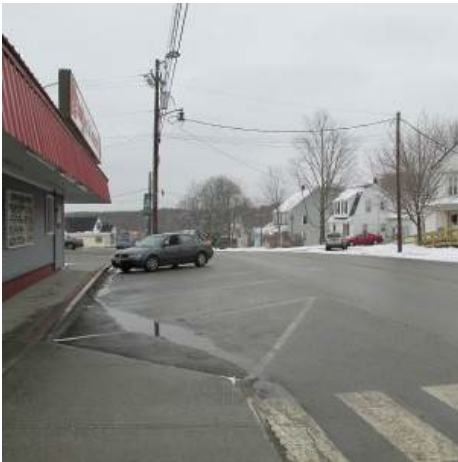
Oakland: Main Street looking west along angled parking tier in front of supermarket.

- Eliminate the crosswalk in front of the café.
- Convert angled parking in front of the grocery to parallel and promote off-street parking availability.
- Improve the crosswalk across the mouth of Pleasant Street to access the sidewalk.
- Designate a pedestrian walkway across the café driveways and the property immediately to the east.

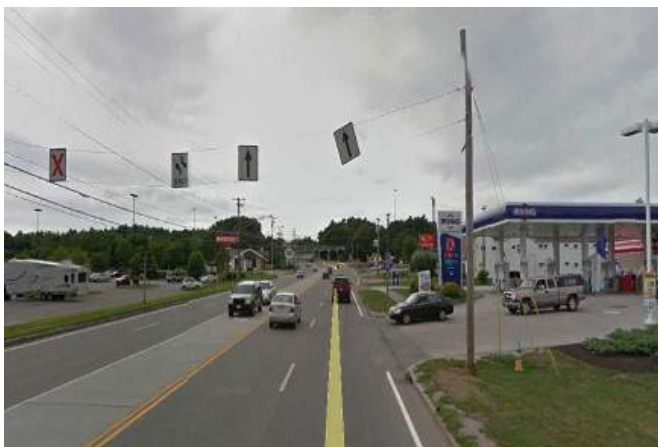
Waterville: Kennedy Memorial Drive looking west, note overhead lane markings and commercial entrances (Image: Google Earth)

- Replace overhead lane marking signage. Replace westbound center lane arrows with an “X”.
- Install temporary changeable message speed notification sign eastbound.
- Enforce permit conditions for road improvements imposed on T&B Celebration Center.
- Limit exiting movements as condition of permit when vacant property is redeveloped.

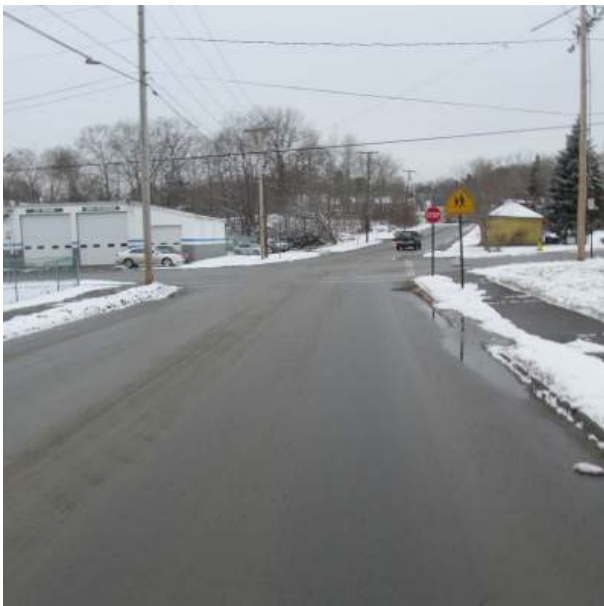
Waterville: On High Street looking west towards Drummond Ave. intersection, undersized STOP sign

- Raise STOP signs so that they are seven feet off the ground.
- Move STOP bar on Drummond northbound leg 10 feet closer to intersection.
- Upgrade the flashing beacons to current standards (dual alternating flashing beacons on each leg of the intersection).

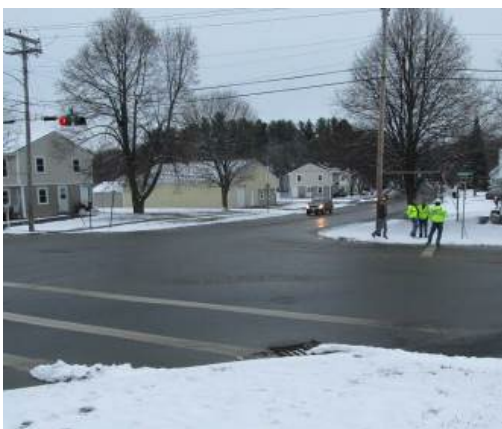
Waterville: Drummond Street (foreground) looking towards Hazelwood, with STOP bar too far back

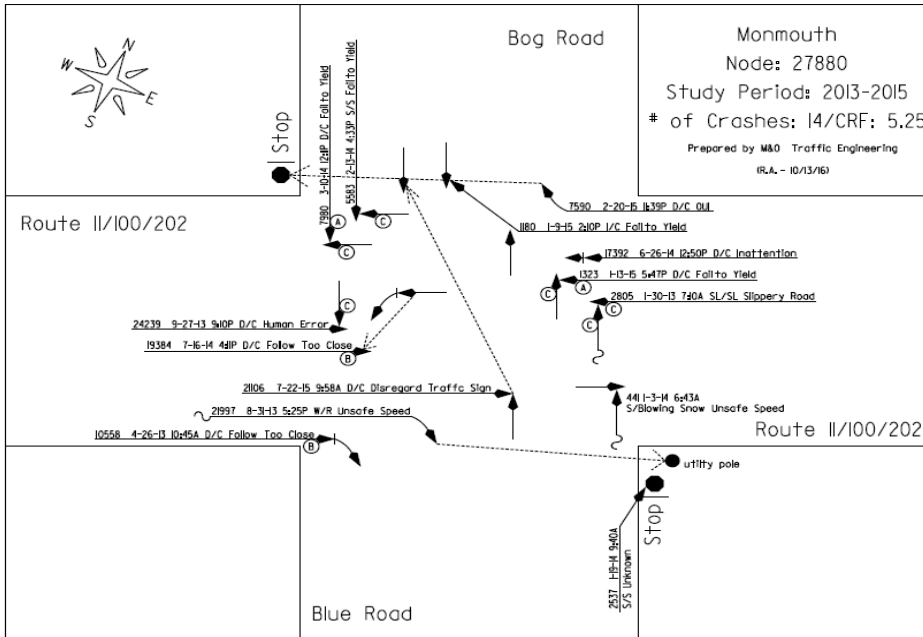
Monmouth
Node: 27880
Study Period: 2013-2015
of Crashes: 14/CRF: 5.25
Prepared by M&O Traffic Engineering
(R.A. - 10/13/16)

Of the 14 crashes at the intersection, 7 resulted in injury, two serious. Four crashes were attributed to failure to yield, with one “disregarding traffic sign.” Snow appears to be a factor and most occurred January through March. There is no time-of-day trend.

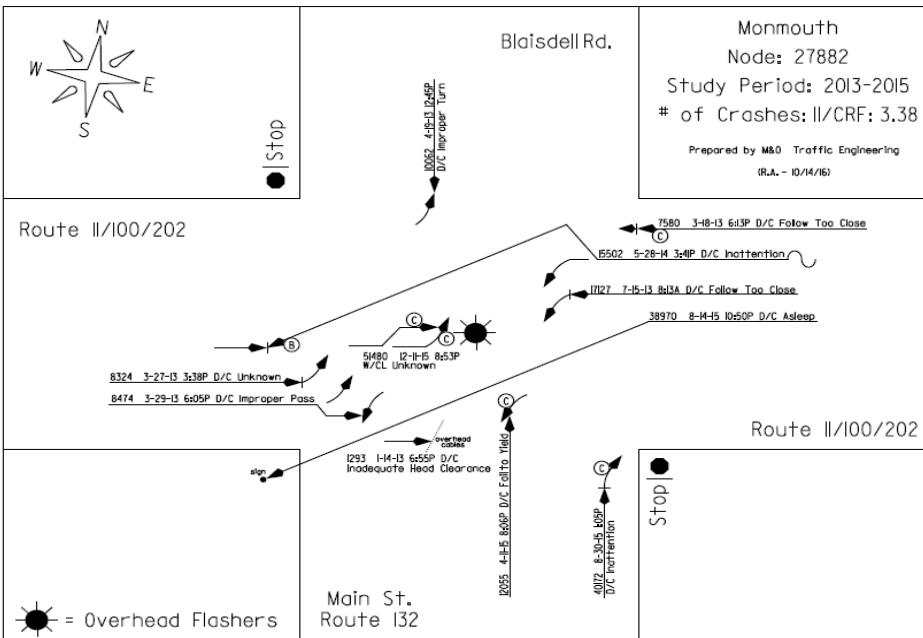
Monmouth
Node: 27882
Study Period: 2013-2015
of Crashes: 11/CRF: 3.38
Prepared by M&O Traffic Engineering
(R.A. - 10/14/16)

Of the 11 crashes at the intersection, five resulted in injury. There appear to be a variety of causes, with no clear trend. All but two involve turning movements. Five of the 11 occurred in the early evening.
