Evaluation and Recommendations for High Crash Locations

In Somerset County

Prepared by Kennebec Valley Council of Governments

October, 2017

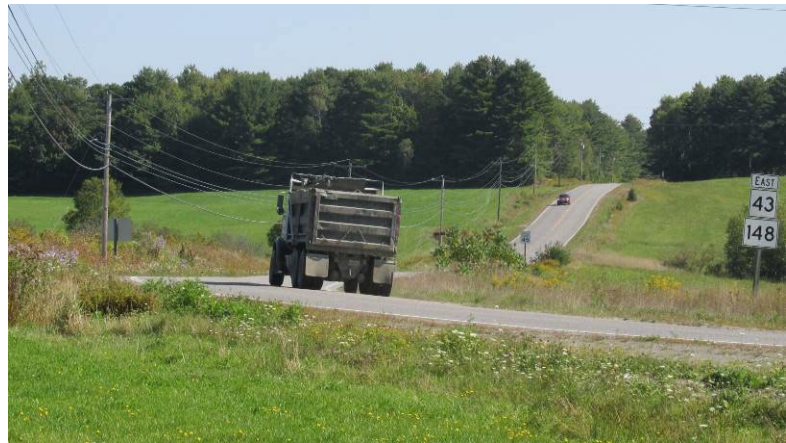
Viewed with town manager and fire chief. This is a wide-open stretch of rural roadway, with open fields and a very slight curvature into an intersection. Snow can drift off the fields during the winter. It was noted that deer commonly graze in the adjacent fields, leading to the conflicts with vehicles. There is also a snowmobile crossing at the eastern end of the segment.

Improve signage for curve, with possible chevrons for eastbound traffic at West Mills Road intersection. Add sign for snowmobile crossing. Consider signage for deer.

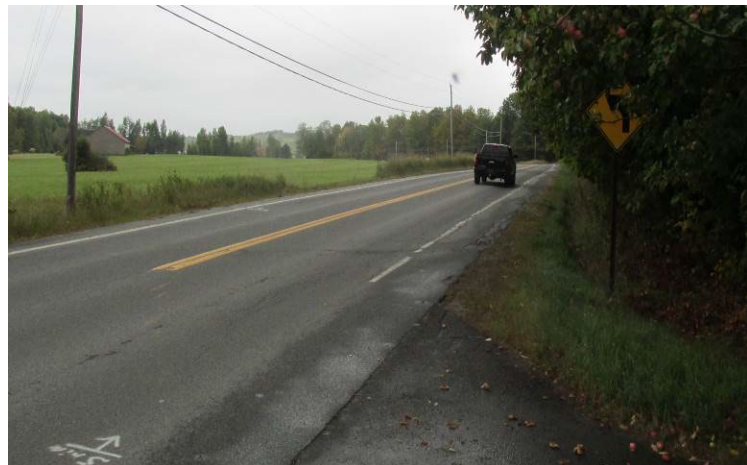
No local officials were available for site visit. It is apparent that the intermittent fields and woods along the road, plus several stream and power line crossings, yield themselves to increased animal crossings, though no one place in particular stood out. Speeding is a factor along the road, even though there are a number of residential driveways.

- Evaluate area for deer crossing signage.
- Improve speed enforcement and winter maintenance.

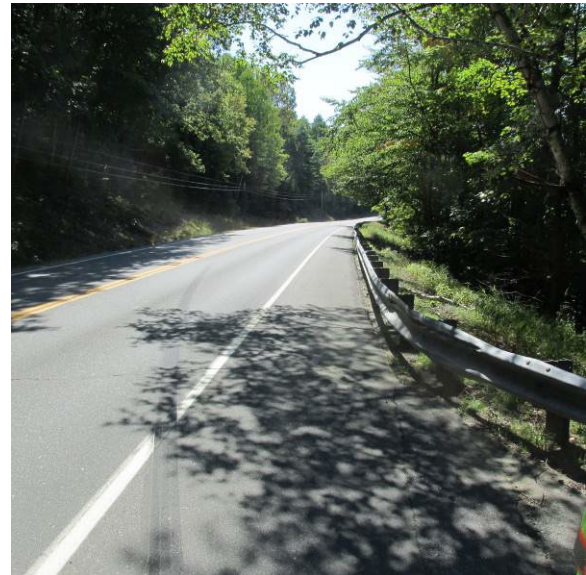
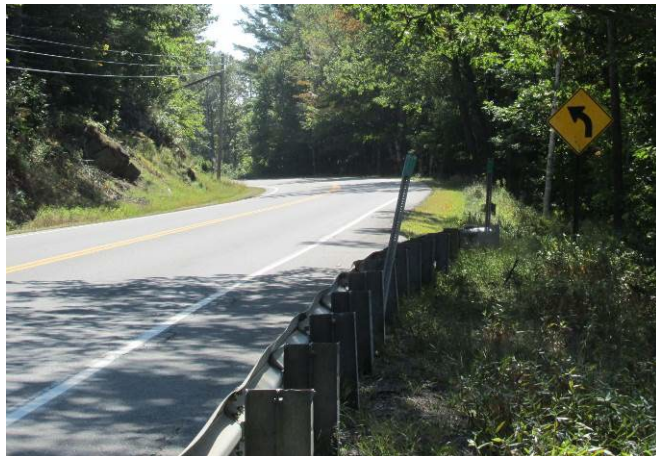
The site was viewed with the first selectman and two fire dept. personnel. The road was viewed from a turnout just southeast of the Katie Crotch Road intersection. This is a shaded area adjacent to the river with curves and steep banks. It was felt that excessive speed around the curves (eastbound and downhill), by trucks and in winter road conditions, was the chief preventable hazard. There also appeared to be some stretches striped as suitable for passing where visibility was inadequate.

- Improve visibility of advance curve signs.
- Increase clearing on south side of road.
- Evaluate pavement striping (dashed lines) for suitable passing sight distance.

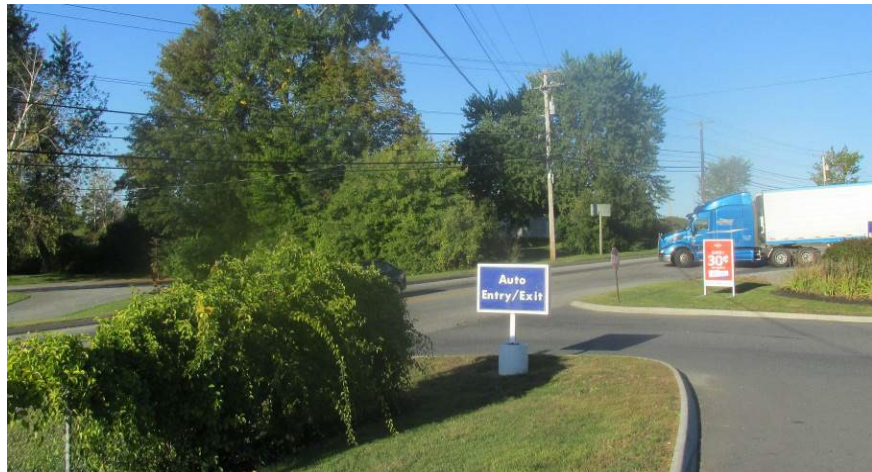
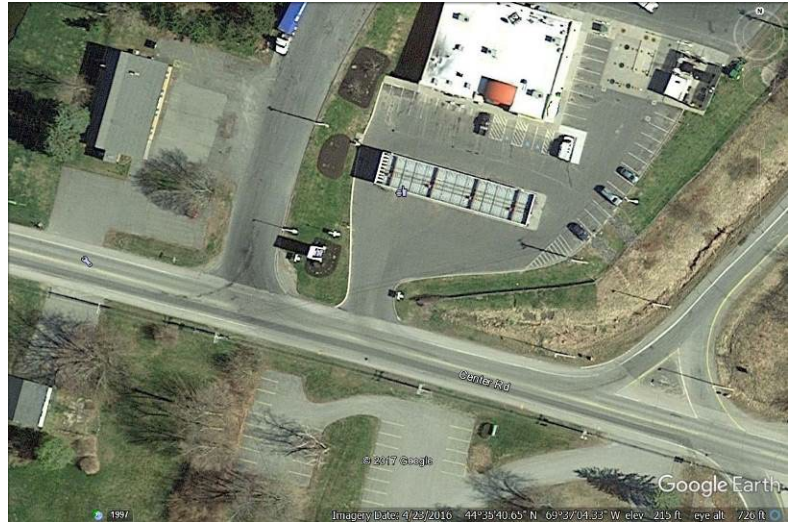
The site was viewed with the local road commissioner, police chief and fire chief. The crashes, as well as congestion, are the result of the entrance design. The curb radii on both sides of the truck entrance are too narrow, forcing trucks to slow down and swing wide on both entrance and exit. There is poor sight distance to the west (over a slight rise), and the entrances are just west of the interstate ramps on a slight grade, causing trucks to move very slowly, as well as forcing backups as trucks wait for others to clear the entrance. This cascades into the auto entrance, as cars dash in and out among the truck movements. The narrow entrance also does not drain properly, causing winter snow/ice buildup and erosion of the road and shoulder.

- Work with the business owner to improve the driveway entrance, including consideration of an island for separation at the entrance.
- Improve drainage to stormwater grate at northeast corner of entrance.
- Long-term: a westbound deceleration lane would provide more room for entering and exiting traffic to maneuver and for through traffic to avoid conflicts.

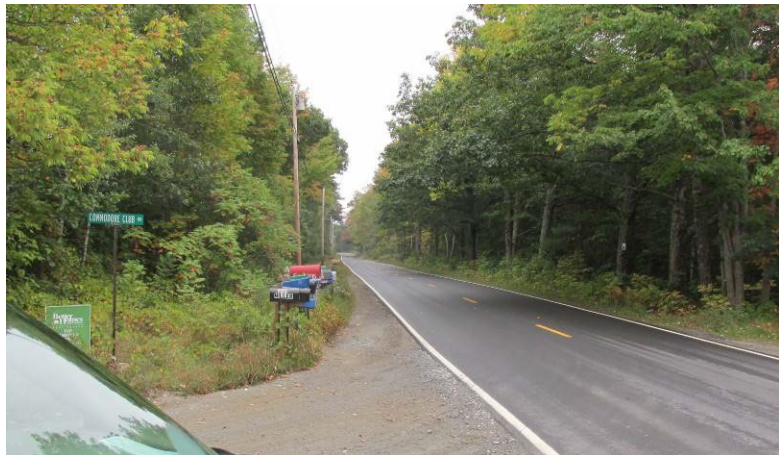
The site was viewed with the town manager and fire chief. The segment of highway had been recently re-paved (2017). It is narrow, with no paved shoulders and close overhang of trees. The road is heavily used by log and construction trucks. While most of the roadside is wooded, there are some open fields that would be attractive to deer. According to the town manager, the road accumulates slush on the curve in winter.

- Improve winter maintenance procedures.
- Investigate deer crossing patterns with possible signage.
- Remove some vegetation along south roadsides for more winter sun.

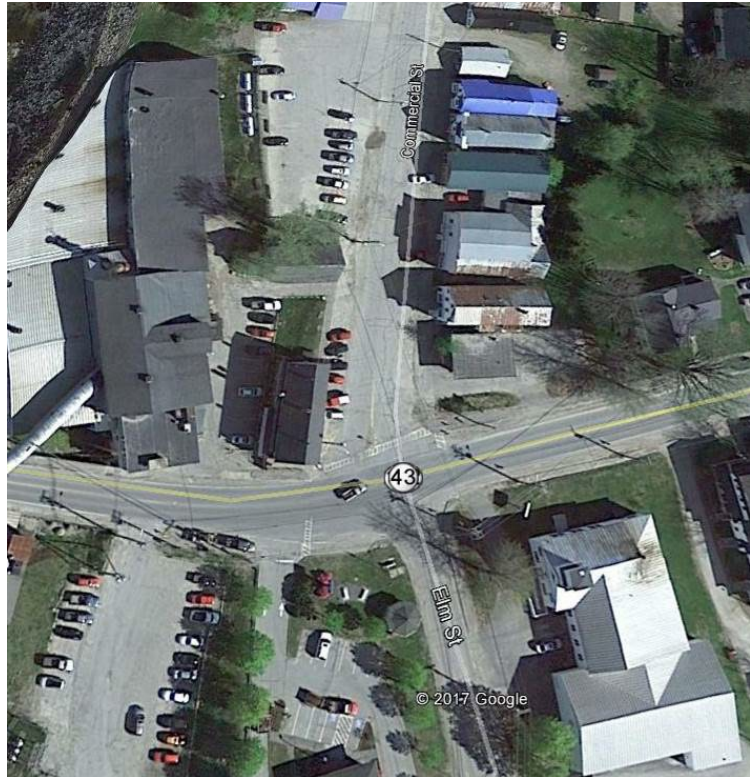
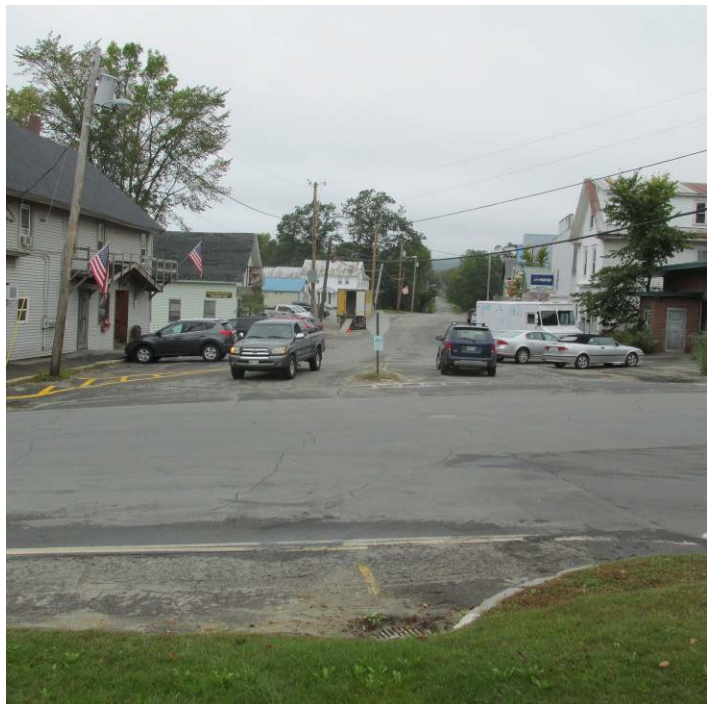
The intersection is not designed for contemporary traffic patterns, primarily due to the Commercial Street leg. Commercial Street has head-in parking on both sides almost all the way up to the corner. The north- and south-bound lanes are separated by an island only about ten feet long and supporting the STOP sign, which regularly gets knocked over. Even though the mouth of Commercial Street is over-wide, trucks have problems negotiating the turn. The curb on the northwest corner is poorly defined and has a storm drain grate in a poor location.

Reconfigure the mouth of Commercial Street. Possible improvements include: reduce head-in parking stalls, extend northwest curb corner to protect parking and provide space for STOP sign, eliminate center island, and shift alignment slightly east to line up better with Elm Street.

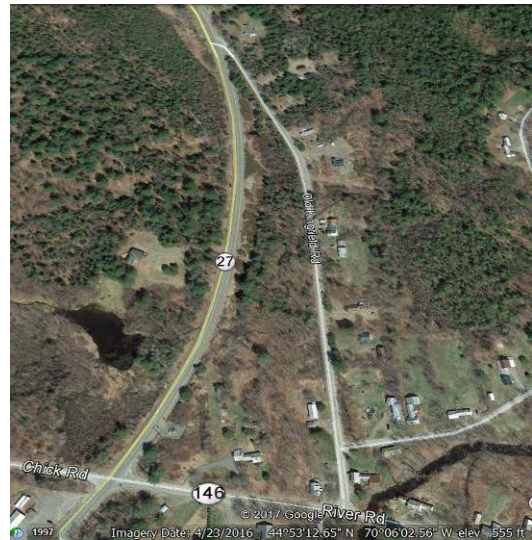
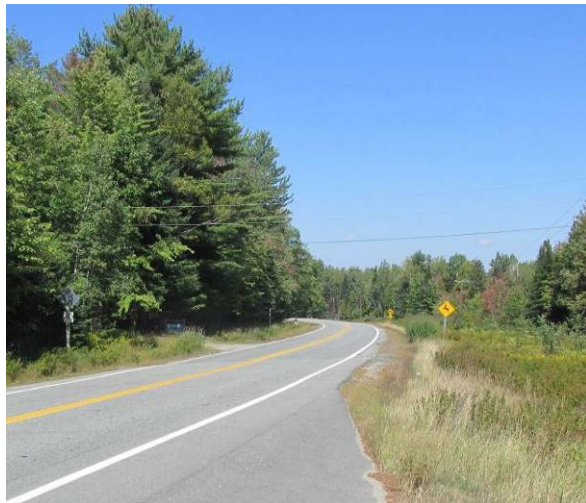
The site was viewed after meeting with the town manager and assistant fire chief. The primary purpose was to determine the source of the deer hits. The West New Portland Village is adjacent to the road segment, and people in town have fed the deer over the years. On the west side of the road, trees right to the ditch line provide good cover. There is already a deer crossing sign posted in the northbound segment and an enhanced one southbound.

- Improve visibility of northbound deer crossing sign, possible lighting.
- Clear vegetation along west side to edge of right-of-way.

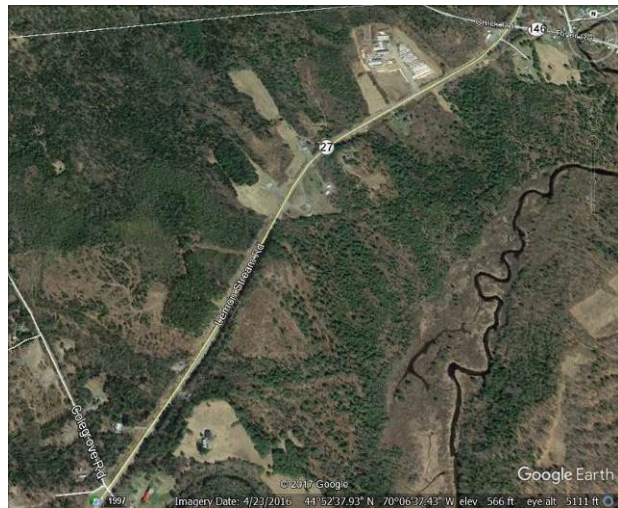
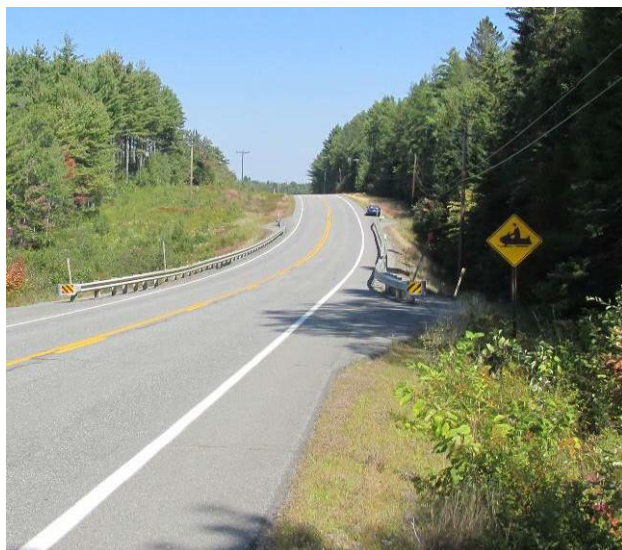
The site was viewed after meeting with the town manager and assistant fire chief. It is a continuation of the Carrabassett Road (element 3112220) segment. We identified the location of the snowmobile trail, which is signed but at a distance of over 600 feet from the crossing itself. There are a few open fields, which could be gathering points for deer.

Move the snowmobile crossing signs closer to the crossing itself.

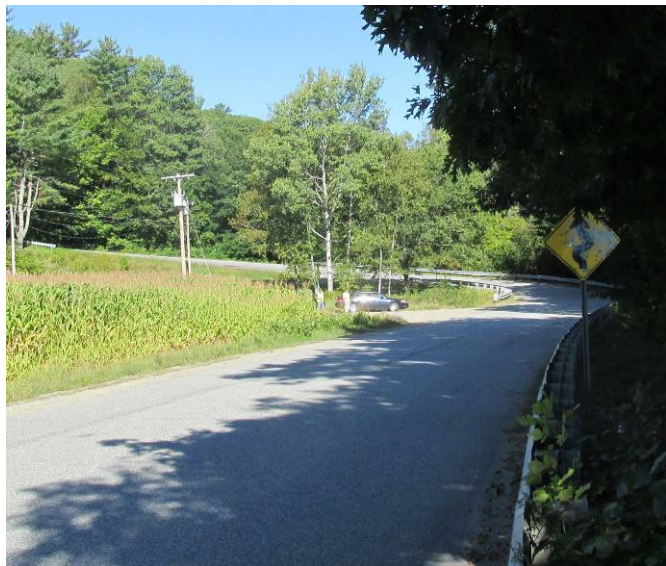
The site was viewed with the town manager and fire chief. The lower portion of the road is flat and straight, but ends in an abrupt hill and set of sharp curves. The road is poorly marked; the curve signs have been vandalized, the curve chevrons are too small, and there is no centerline striping.

- Upgrade chevron signs at upper curve.
- Paint centerline stripe

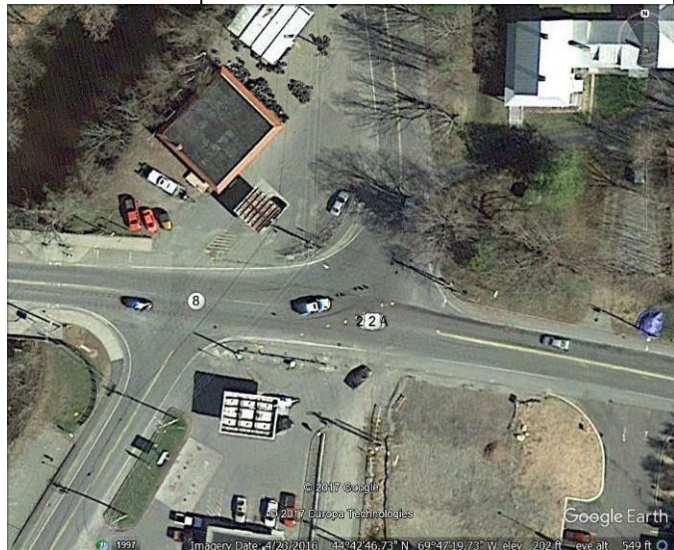
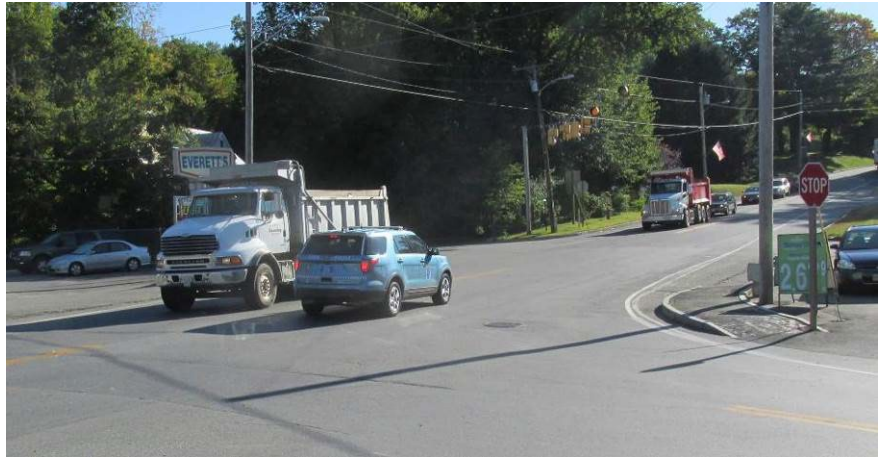
The site was viewed with the town manager, fire chief and sheriff's deputy. There are a lot of turn movements in a small area, complicated by confusion on the part of eastbound drivers as to whether or not to signal to stay on Route 2, which is a left turn. The convenience store has access problems, with one onto Hotel Street and another right at the corner of Main Street and Mechanic Street. (The town has discussed closing off Hotel Street, which would force store traffic onto Mechanic Street.) The auto service store is increasing its business.

Traffic entering the intersection on Route 139, controlled by the STOP sign, alternately backs up to the top of the hill and moves freely.

- Place a STOP AHEAD sign on Route 139 approaching the intersection.
- Improve visibility of route directional signage.
- Remove or scale back the parking and curb extension on the south side of Main Street at the Mechanic Street intersection, to provide enough room to create dual lanes at the 139 intersection – one for straight through, one for left turn only. This will eliminate uncertainty on the part of Route 139 traffic as to whether oncoming traffic is turning or not.
- Add a STOP bar on Mechanic Street.
- Move STOP sign and add a bar on Hotel Road.
- Clear vegetation on northeast corner of intersection.

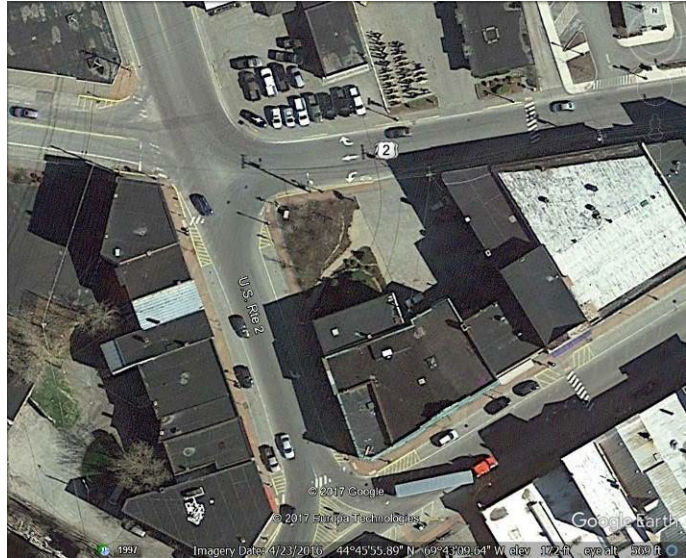
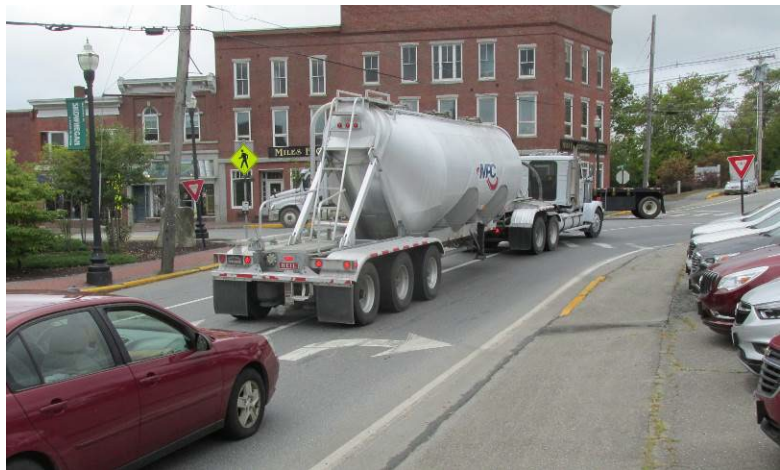
The site was viewed with the Skowhegan police chief and public works director. The intersection flows fairly well, except that the numerous large tractor-trailers must use two out of the three lanes to make a turn, because both curb radii are too tight. Vehicles coming out of Commercial Street either straight or

left can have a hard time judging the speed of traffic coming down Madison Ave., and Madison Ave. traffic is shifting lanes preparing to turn either left or right at the oncoming US Route 2 split. One vehicle attempted to turn left into one-way Commercial street while we were watching.

The crosswalk just south of the intersection is a hazard because of its proximity to traffic turning left, where drivers are focused on trying to judge oncoming traffic from the right.

It was recommended to the Town that they apply for Planning Partnership Initiative funding from DOT to study the intersection as well as the one immediately to the south. (Traffic flow around the flatiron block has been studied a number of times in the past in the context of overall flow.) Ideally, the right-turn-only lane from Commercial street should have a broader curb radius or a slip lane to accommodate trucks.

- Improve advance route notification signage on Madison Ave – possible overhead signage indicating no turn onto Commercial Street and the lane preference for Route 2 east vs. 2/201 west/south.
- The crosswalk just south of the intersection should be moved or eliminated.
