Evaluation and Recommendations for High Crash Locations in Kennebec County

Prepared by Kennebec Valley Council of Governments
Draft, December, 2016; Revised, with DOT Action Plan added, June, 2017

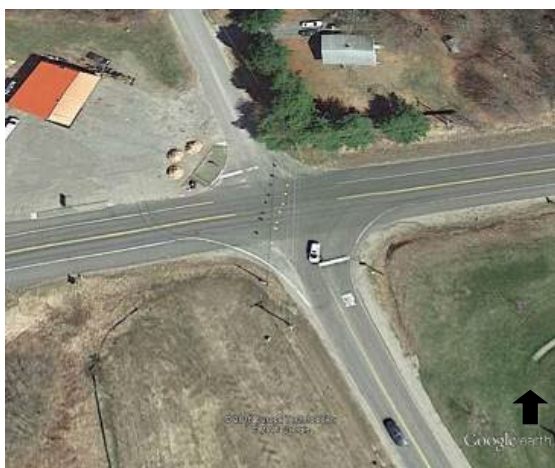
*Monmouth: Route 202/Main Street (to south)/Blaisdell Street (to north)
(Image: Google Earth)*

Of the 14 crashes at the intersection, 7 resulted in injury, two serious. Four crashes were attributed to failure to yield, with one “disregarding traffic sign.” Snow appears to be a factor and most occurred January through March. There is no time-of-day trend.

The hazards at this intersection are typical of a high speed, low-volume rural crossing. There is a slight reduction of sight distance on Route 202 heading east into the intersection due to a gradual curve and vegetation on the northwest corner. Additional evergreen vegetation south of 202 and along Blue Road may contribute to icy conditions, but may be located on private property. The business on the northeast corner is a fireworks store, seasonally busy, and the tier of parking along the curb when occupied interferes with sight distance.

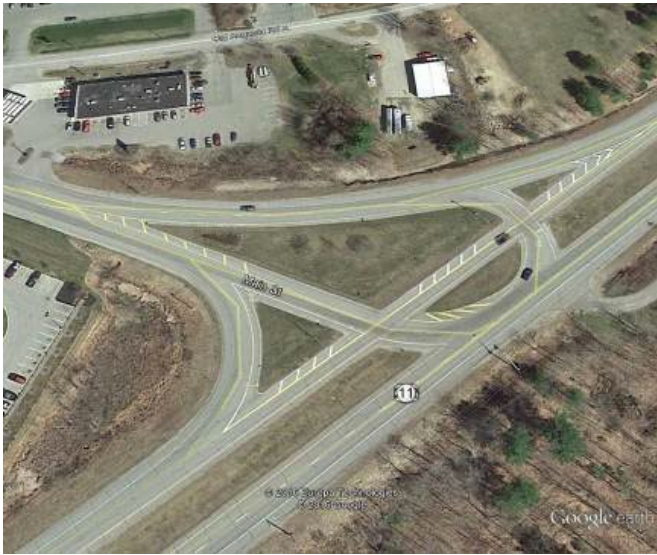
Winthrop: Intersection of Main Street and Route 202, current design. (Image: Google Earth)

Crash History – Node P28703	
Total Crashes	25
CRF	4.78
Rank in County	7

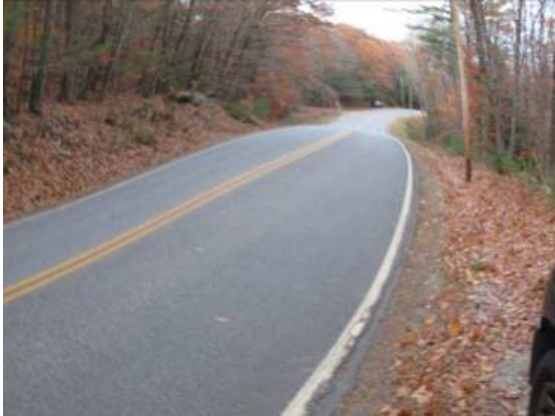
Winthrop Center Road north of Pine Point Lane, looking north.

Of the 13 crashes, 6 resulted in injury. Only one involved more than one vehicle. Three involved an animal. Six involved unsafe speed – almost all in snowy conditions. There is no trend in time of day or year.

- Provide curve warning signs where warranted.
- Work with adjoining landowners to remove some of the trees to open up the road to more winter sun.
- Increase winter maintenance to reduce icy conditions.
- At the next Light Capital Paving, grind the crown or build up the outside on curves, to eliminate the slight reverse superelevation.

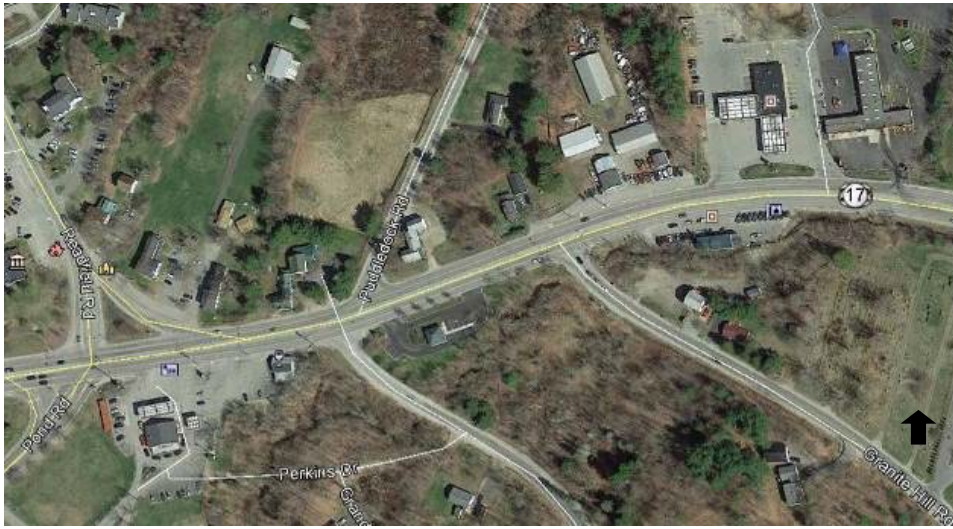
Manchester Route 202 east of Route 17 (Image: Google Earth)

Section 3115993 adjoins a busy intersection that is not an HCL, but within the section, there have been eight crashes in the three-year period. Of the eight crashes, seven of them appear to be associated with turning movements into or out of the convenience store/Dunkin Donuts. Six are attributed to “failure to yield.” All occurred during daylight hours.

Section 3108742 experienced 13 crashes during the three-year period, four of which resulted in injury. All but one of the 13 appear to be associated with turning movements into or out of the J & S Oil service station. All of those are attributed to “failure to yield.” Three vehicles were attempting to enter the development from eastbound Route 202; of the nine exiting, five were attempting to turn left to eastbound, one was turning right but into the left-hand lane, and three were unclear from the crash diagram. There did not seem to be a discernable pattern in time of day or year.

- Coordinate traffic signals between Granite Hill Road and Route 17 to permit larger gaps in traffic. Note that the municipality has collected \$10,000 in impact fees for this purpose.
- Grind out old striping and repaint center-road striping.
- Evaluate left turn pocket for westbound turn into Granite Hill Road and eastbound center lane to see if transition can move further westward.

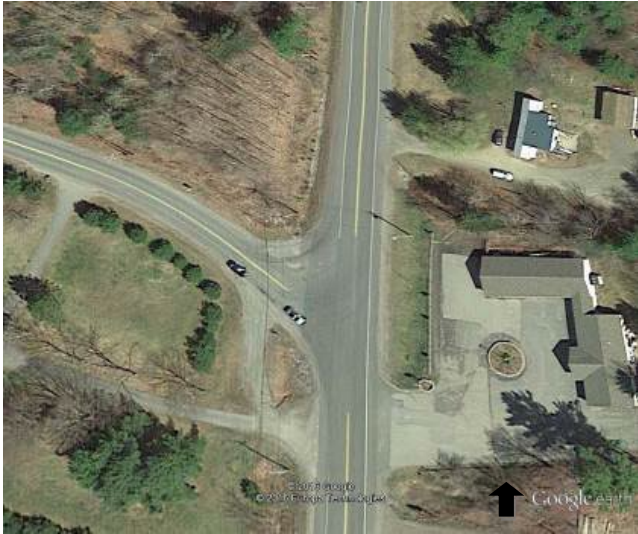
Augusta: Intersection of Route 27 (top to bottom) and Summerhaven Road (Image: Google Earth)

The Summerhaven leg of the intersection is fairly wide. Summerhaven Road approaches the intersection over a slight hill and at a fairly pronounced downward grade. This could definitely contribute to loss of control on wet or snowy roads if vehicles came over the hill without slowing. A STOP AHEAD sign on Summerhaven Road is located about 550 feet from the intersection. The hill to the north on Route 27 contributes to a lack of sight distance. This could cause uncertainty on the part of drivers entering from Summerhaven Road.

- Place a second, oversized STOP sign on the left side of the Sumerhaven Road to aid visibility, and increase the size of the right-hand sign, moving it closer to the edge of the road and STOP bar.
- Extend the double yellow line on Summerhaven Road so that it approaches the Route 27 edge-of-travelled-way, and add a stop bar.

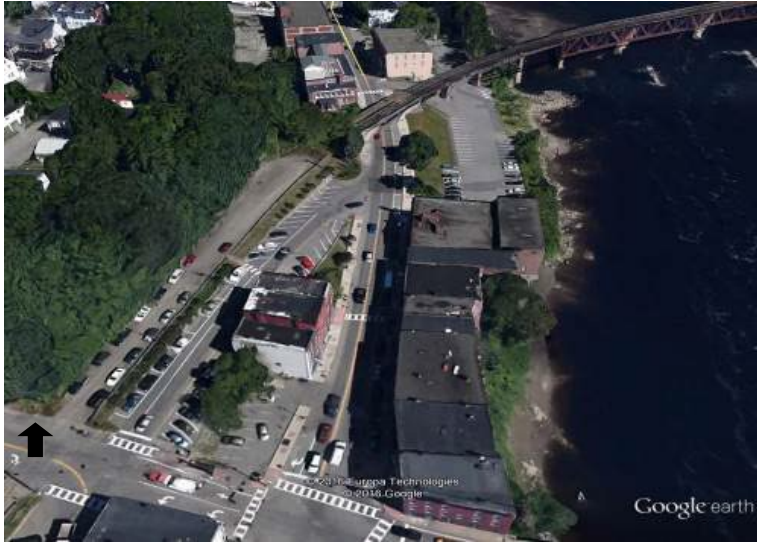
Augusta: Water Street (Image Google Earth)

There are three high crash locations in this segment. The intersection of Water Street with Bond Street and Northern Ave. has experienced 13 crashes in the three-year period, two of which resulted in injury. Six of the crashes resulted from left-turning traffic failing to yield, with another three crashes being northbound traffic following too close to left-turning stopped vehicles. Two crashes involved pedestrians in crosswalks (one after dark). There was no pattern in time of day or year.

Since the bridge hazard is being addressed, attention was focused on the crosswalks. The crosswalk to the south is a mid-block crosswalk. While it would be safer to move it further from the Bridge Street intersection, it serves specific businesses whose customers would probably ignore the crosswalk otherwise. All three pedestrian incidents took place on the northbound lane. Visibility is somewhat impeded by a parking tier on the east side. The sign northbound is mounted to a light pole actually 20 feet beyond the crosswalk.

- The crosswalks should both be marked with rectangular rapid flashing beacons (RRFB) for northbound traffic. This is particularly important at the mid-block crosswalk located north of the railroad overpass, where the railroad bridge seems to impede visibility.
- The pedestrian crossing sign northbound at the southern crosswalk should be moved closer to the actual crosswalk.
- Consider relocating the southern crosswalk if business locations change.
- At the Water/Bond Street intersection, extend the Water Street double-yellow striping further into the intersection.

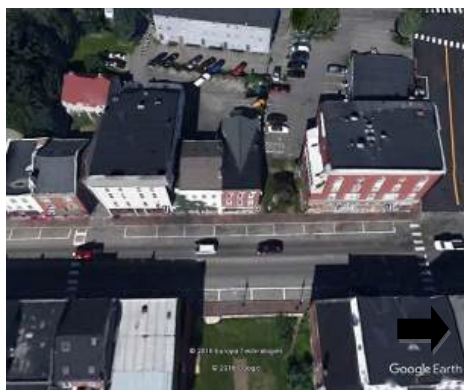
Water Street in Hallowell from Dummer's Lane (left side) to Winthrop Street (right side) (Image: Google Earth)

Water Street is busy and congested much of the day. This segment is typical of the downtown area in general which, along with heavy left-turning movements at Winthrop Street, crossing pedestrians, and parallel parking both sides, creates considerable hazards. In addition, the road segment is designated as part of the Kennebec River Rail Trail for bicycle travel. One side of the street is considerably lower than the other, creating an exaggerated crown and side-to-side slopes.

- Place an RRFB at the crosswalk adjacent to Winthrop Street. Complement it with another placed at the south end of downtown, where the rail trail merges onto the street.
- Mark crosswalks with raised reflectors as well as the standard paint design.
- In design, increase parking stall length from 18 to 20 feet.
- In design, retain the Dummer's Lane crosswalk.
- Mark sharrows with standard design paint and signage.

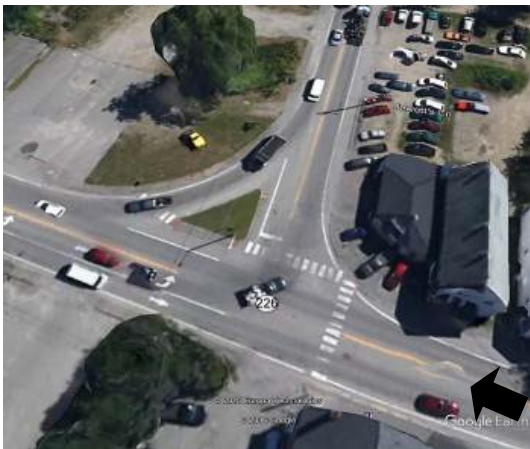
Intersection of Windsor Street (to top) with Water Street (left to right) in Randolph. (Image: Google Earth)

The intersection is constrained by tight circumstances. The right-of-way does not extend beyond the edge of the sidewalk on the east side. The auto repair shop on the southeast corner is wedged in and cars are parked immediately adjacent to the shoulder line, obstructing sight distance.

- The island separating the intersection from the slip lane can be extended closer to the shoulder line with STOP and YIELD lines coming out correspondingly, allowing drivers from Windsor Street to venture further past the sight obstruction. The anticipated expense of doing so would likely make this a capital project.
- The light pole located within the traffic island should be moved to the west side of Water Street.
- Mitigation for the new development should focus on redesign of the slip lane with a longer merge onto Water Street.
- The business on the southeast corner should prohibit parking up against the right-of-way.

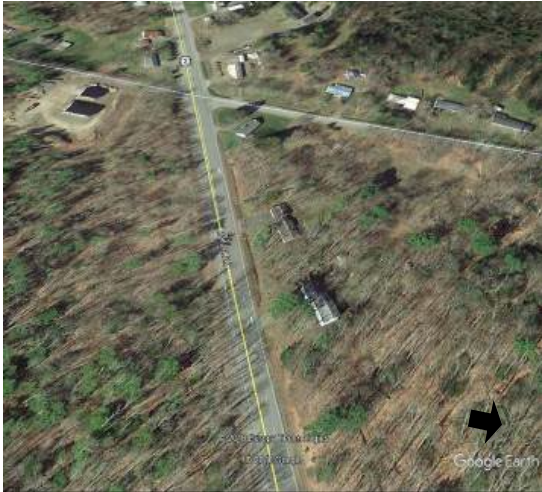
North Belfast Ave. (Route 202) looking westward (Image: Google Earth)

Of the 12 total crashes, two resulted in injury. Five were deer hits or loss of control avoiding deer – all at night. Four were loss of control in snowy conditions – three westbound. In four cases, drivers left the road and one resulted in a head-on collision in snow.

Although this segment is showing up as the HCL, clearly the hazardous portion of this roadway is the intersection at the southwestern end. It is one of the two intersections in Maine with two separate fatal crashes. Part of the cause is the lack of sight distance for entering traffic at the crest of the hill, part is the two lanes of westbound traffic to cross, and part is the speeds along the roadway. The climbing lane is too short to accomplish much and vehicles are speeding up to finish a pass and merge; entering vehicles must gauge closing speeds with less-than-ideal sight distance.

An additional hazard on the road is the proximity of trees shading the road in winter. However, the snow-related crashes were on the north side, having received more sun than the south side. There were no indications of deer crossing signs in the area.

- Eliminate the climbing lane, which is too short to fulfill its function, and consider restriping the roadway to allow for the addition of left turn lanes within the existing travel way footprint.

- Evaluate for the possibility of installing deer crossing signs.
- Install flashing beacons.

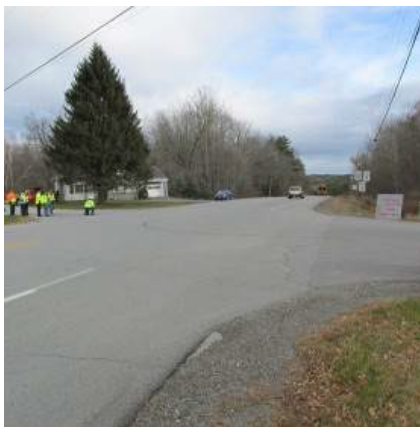
Vassalboro: North Belfast Ave. looking east through Stone Road intersection at top of hill.

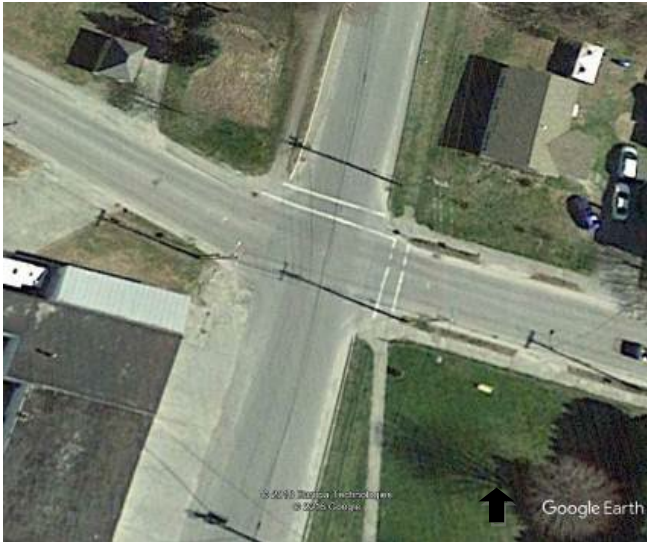
*Intersection of Drummond Street (top to bottom) with High Street (left to right)
(Image: Google Earth)*

Crash History – Node 25750	
Total Crashes	8
CRF	5.71
Rank in County	4

- Add STOP bars on both High Street legs.
